# THE FAILURE OF THE TACOMA NARROWS BRIDGE

A Report to the  
Honorable John M. Carmody  
Administrator, Federal Works Agency  
Washington, D. C.

## BOARD OF ENGINEERS

MARCH 28, 1941

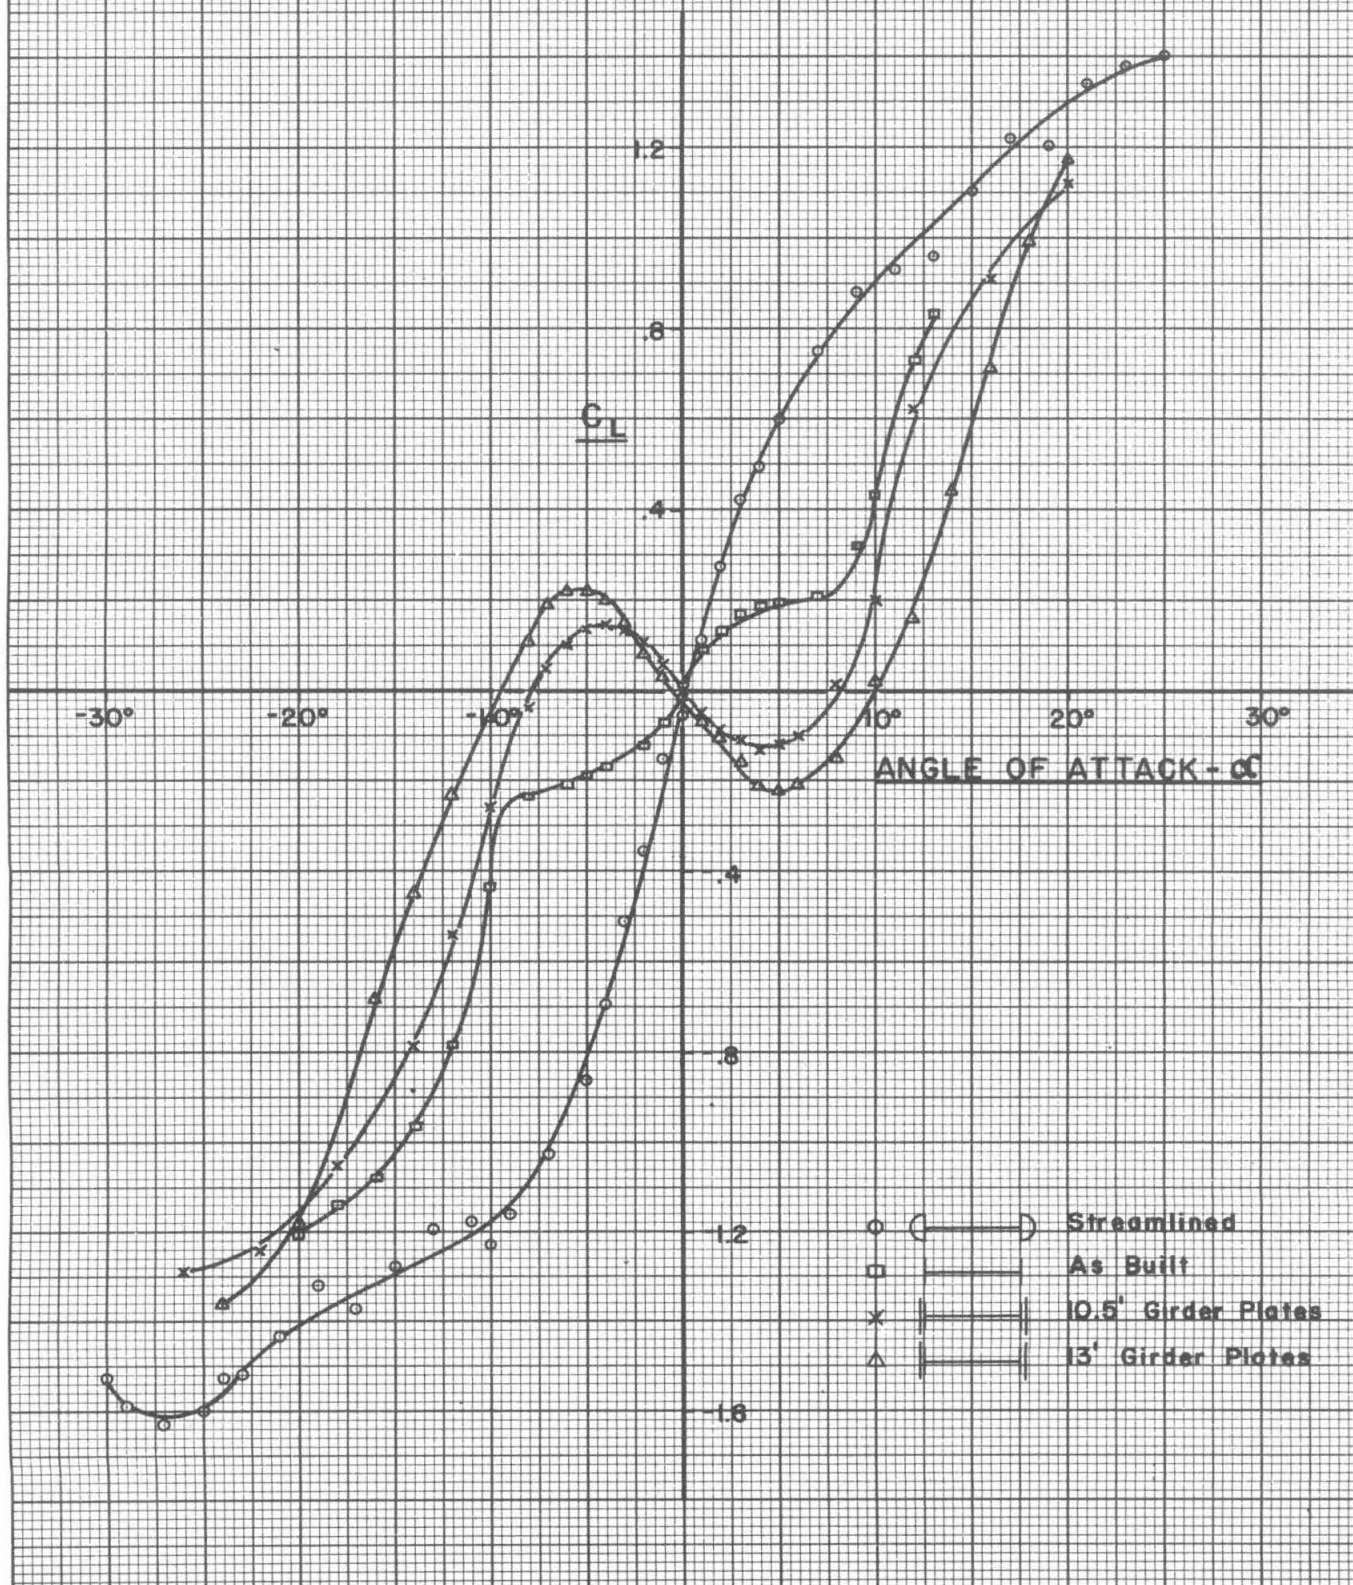
FIG. VIII-18  
LIFT CHARACTERISTICS  
OF VARIOUS SECTIONS  
FROM GALCIT TESTS

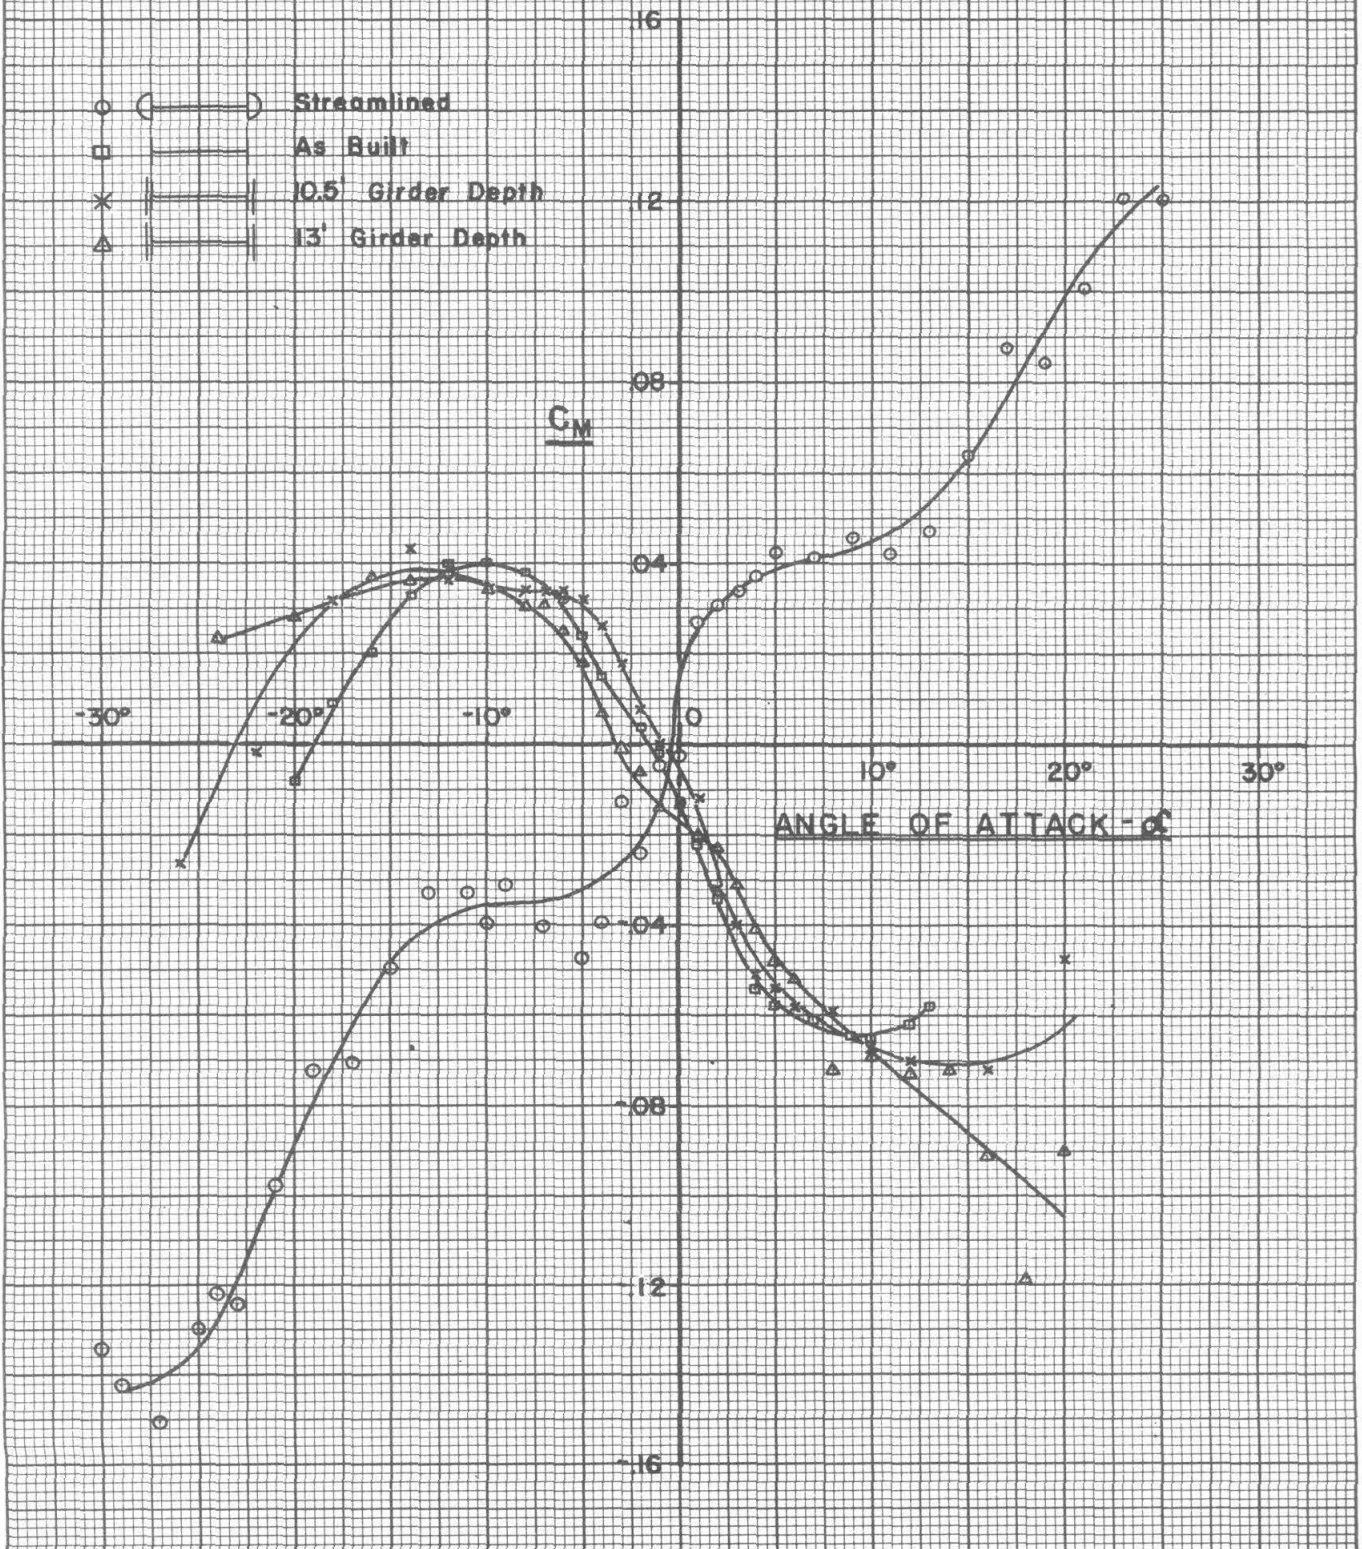
**FIG. VIII-19**  
**MOMENT CHARACTERISTICS**  
**OF VARIOUS SECTIONS**  
**FROM GALCIT TESTS**

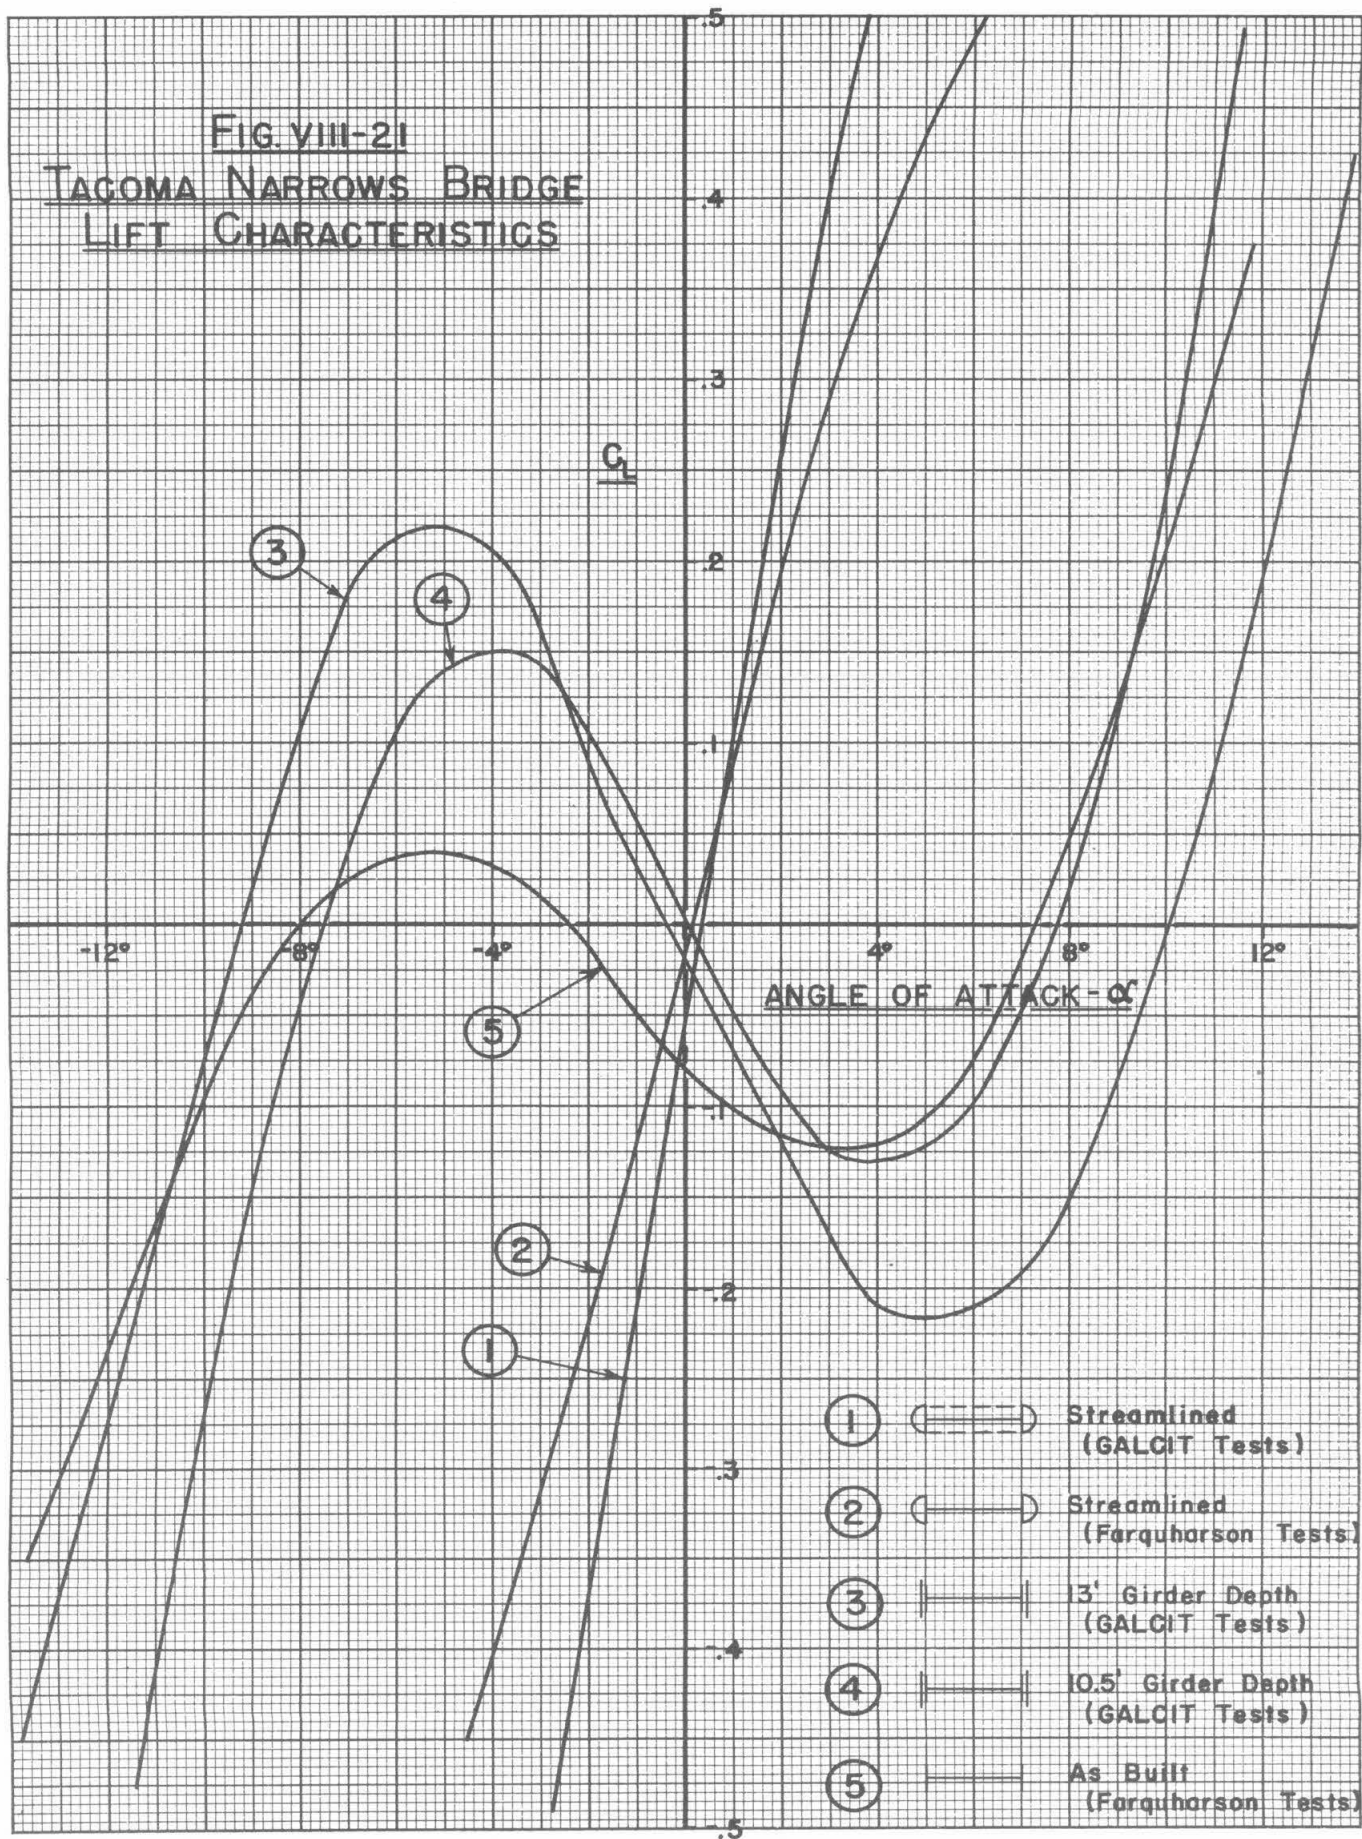
FIG. VIII-21  
TACOMA NARROWS BRIDGE  
LIFT CHARACTERISTICS

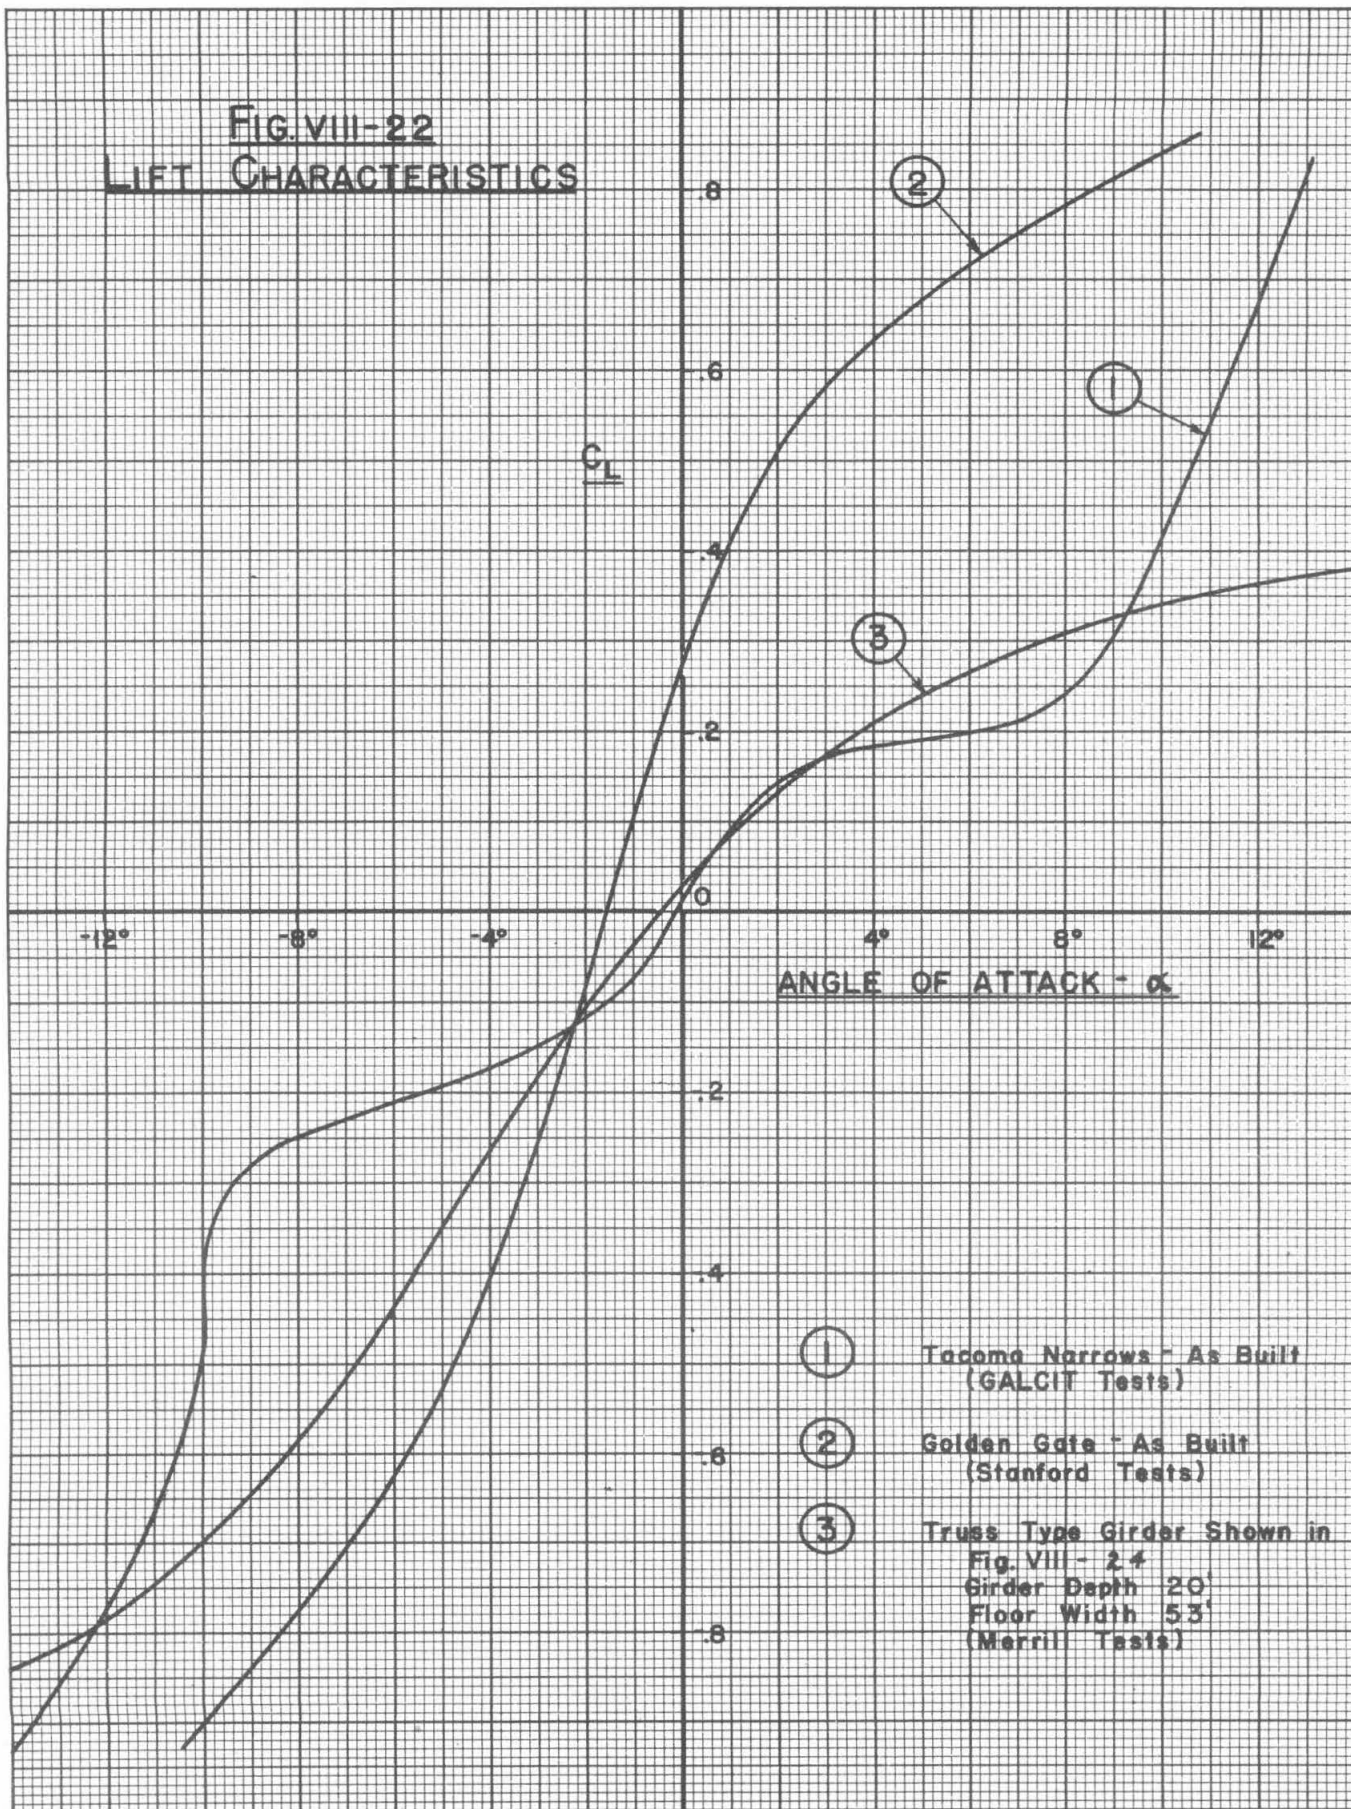
**FIG. VIII-22**  
**LIFT CHARACTERISTICS**

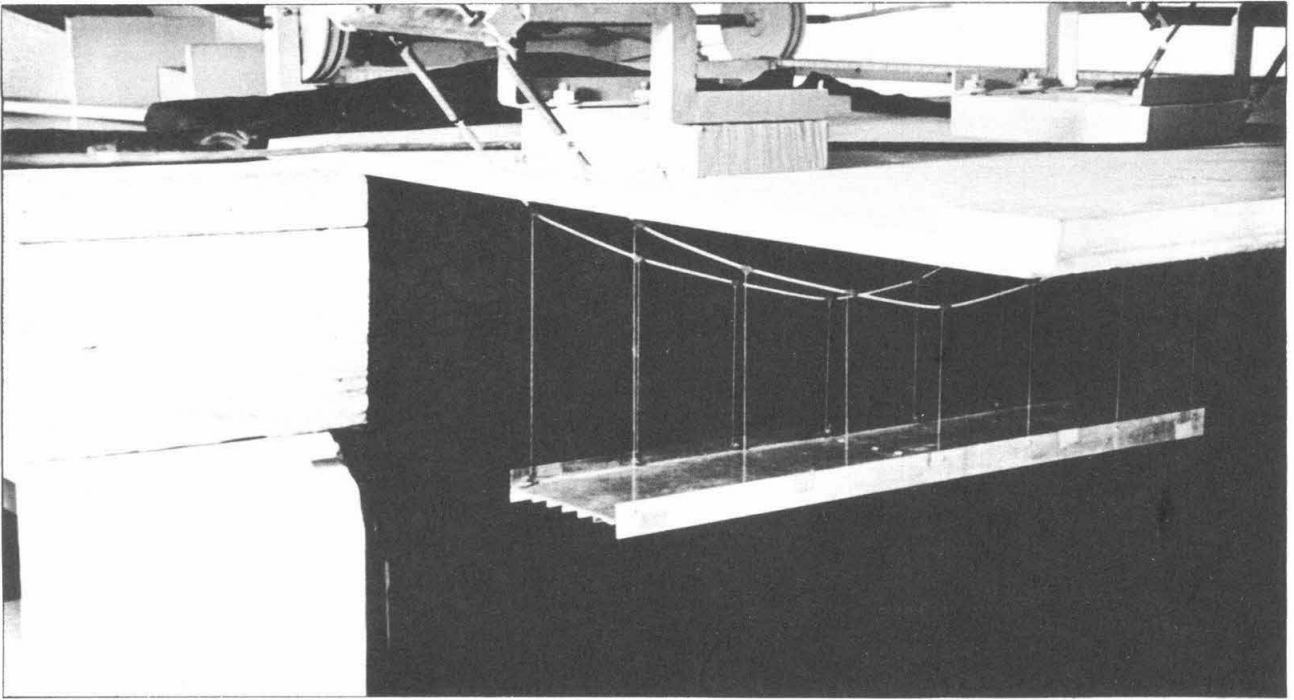
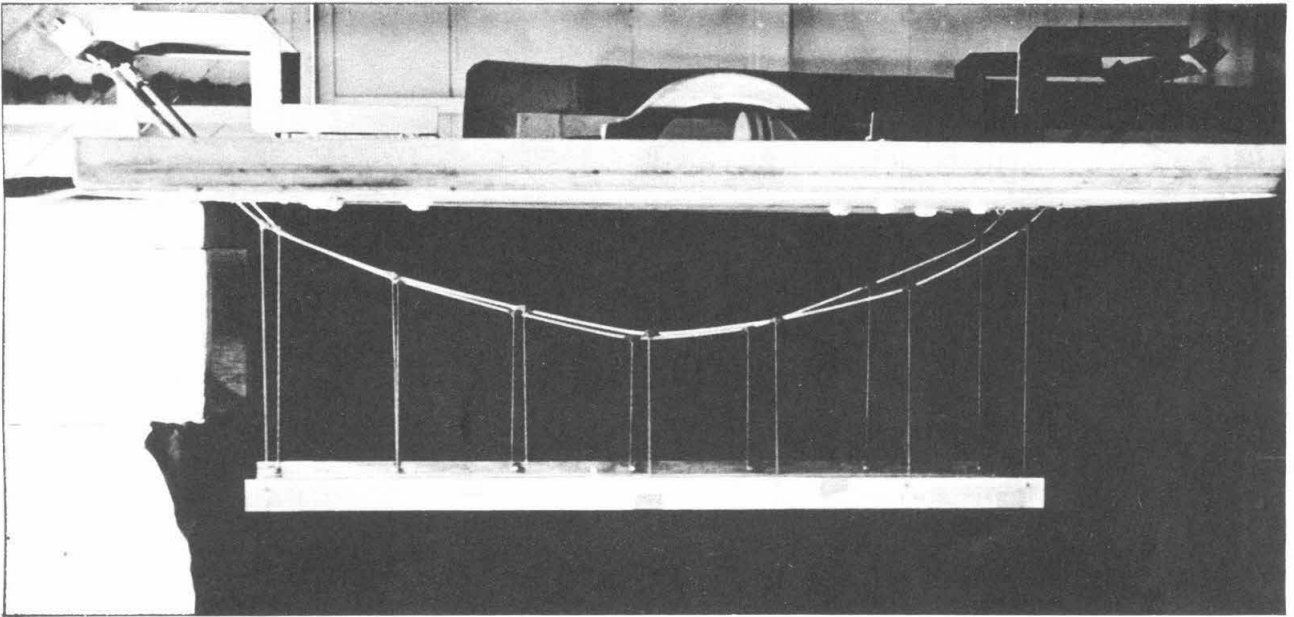
Fig. VIII-23. Model of the Tacoma Narrows Bridge  
suspended in the wind tunnel for dynamic test.

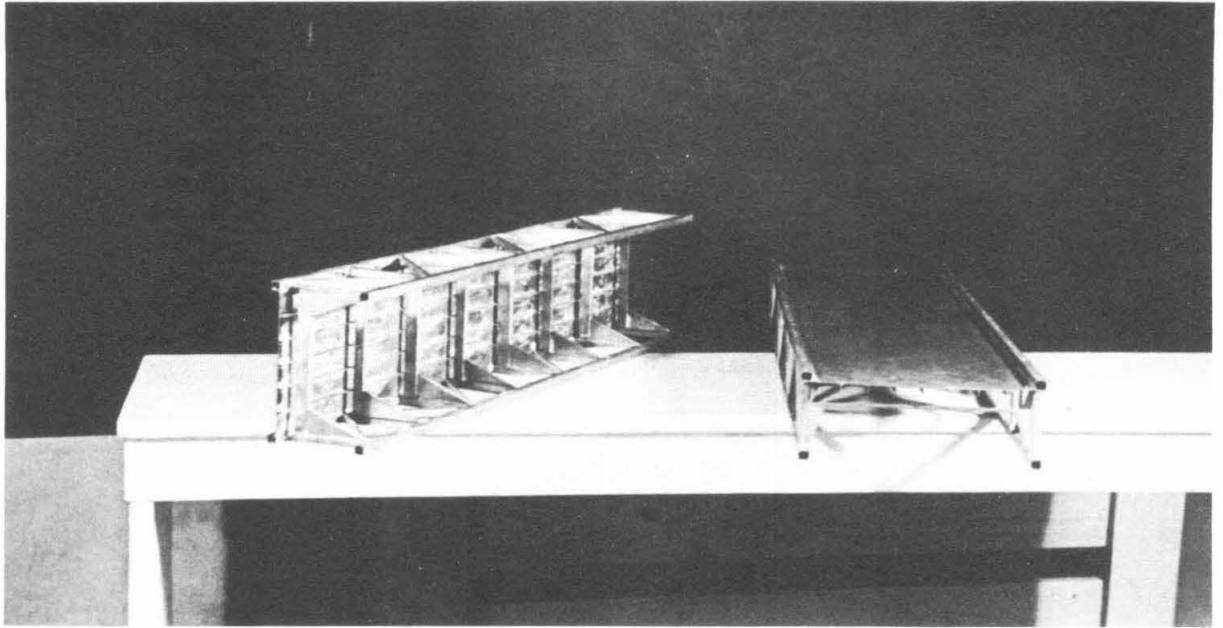
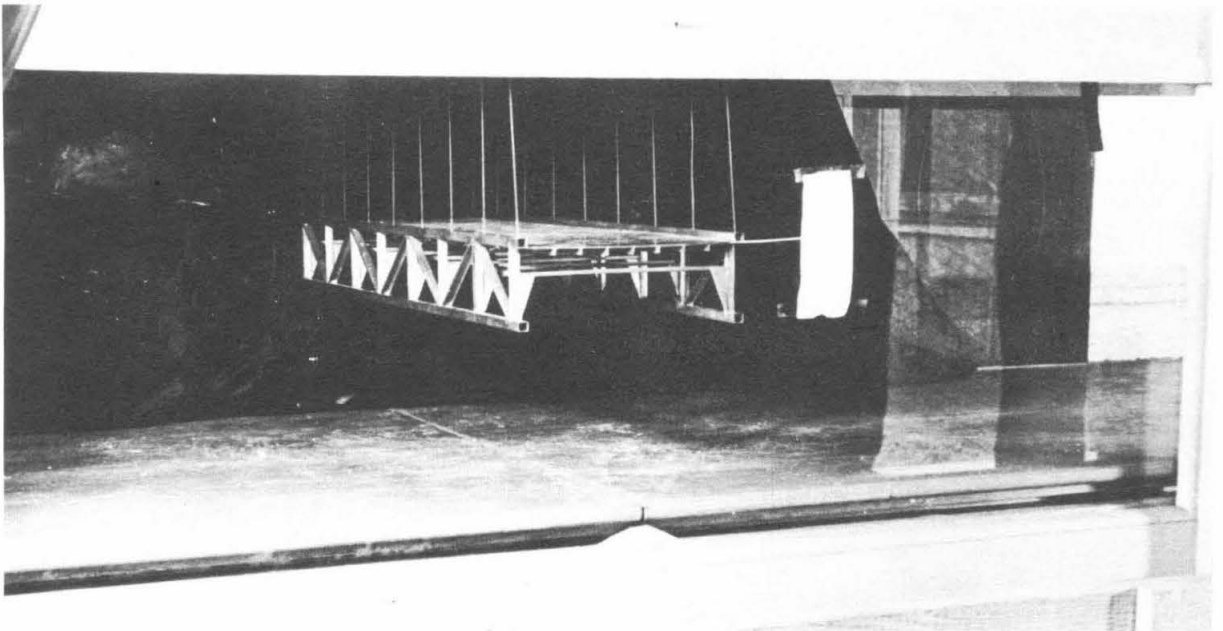
Fig. VIII-24. Models with deep girders.

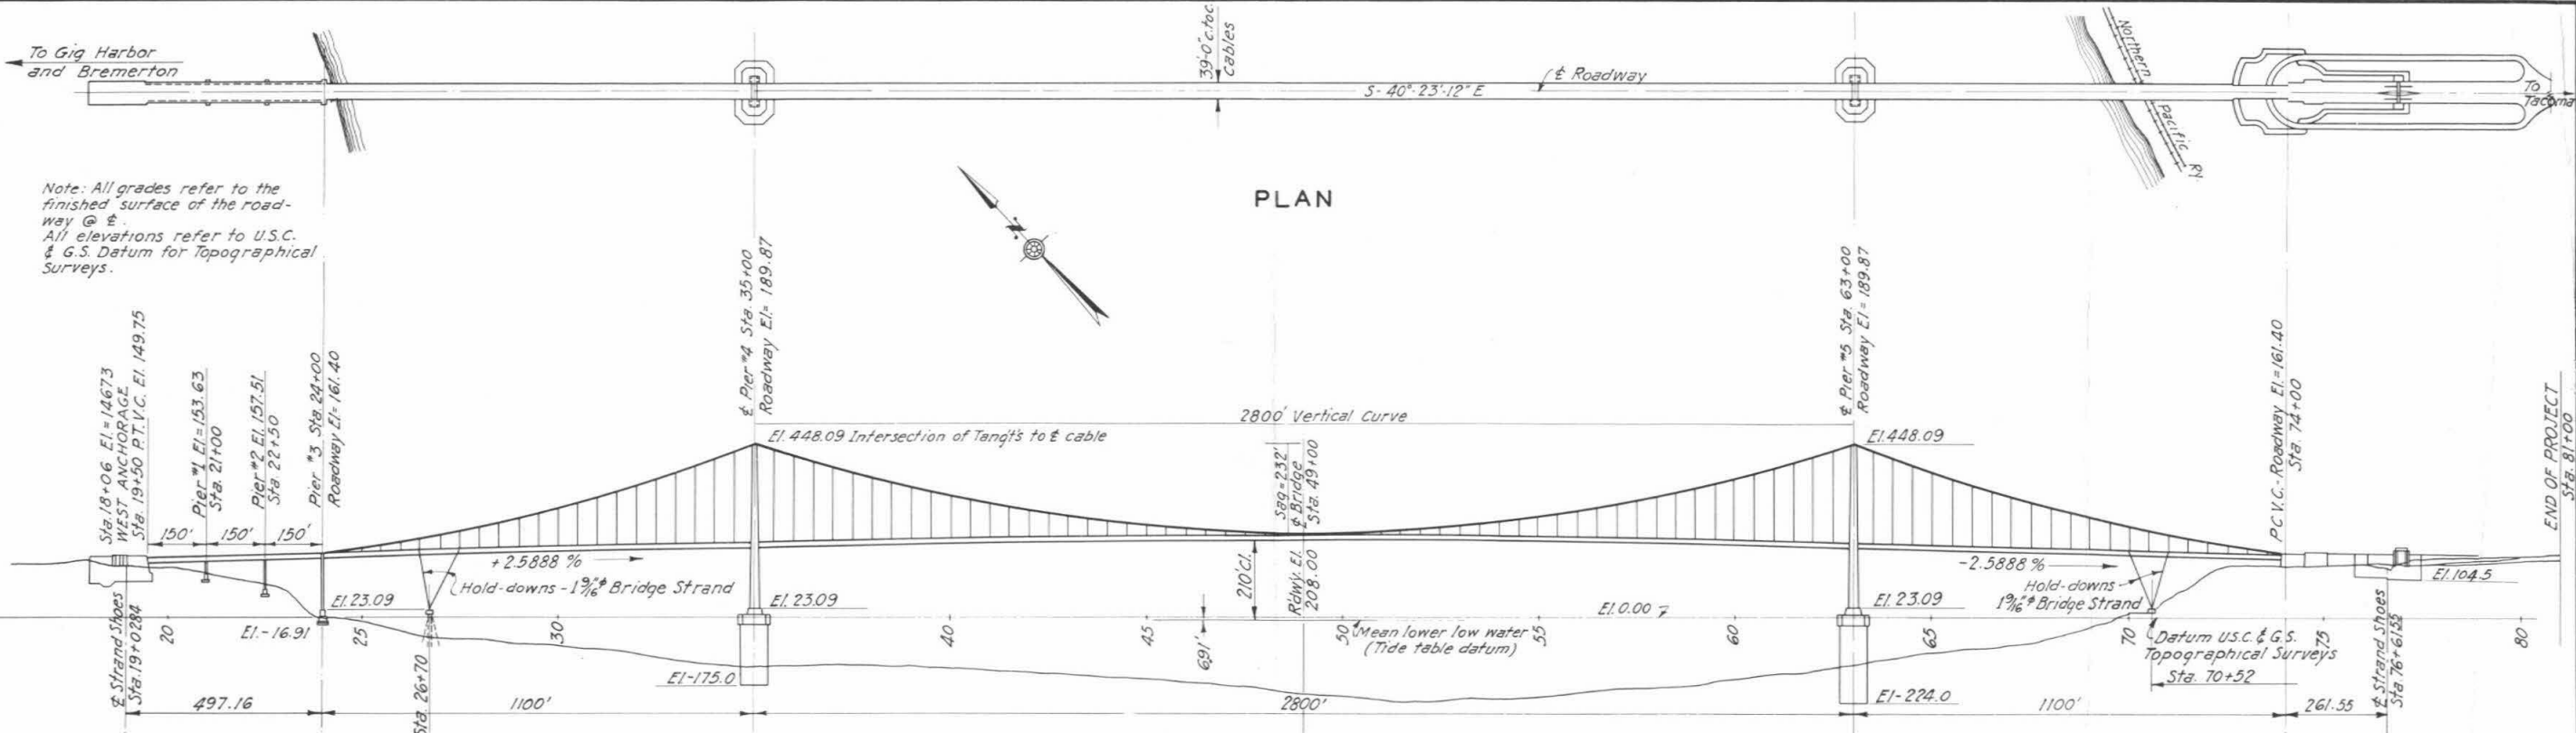
MARCH 1941 DRAWING 1

Cable  
19 Strands  
332-No.6 Wires per st  
6308 Wires per Cable  
Cable Diam.-17 1/8"

5 Stringers, expansion seats every 150 ft.

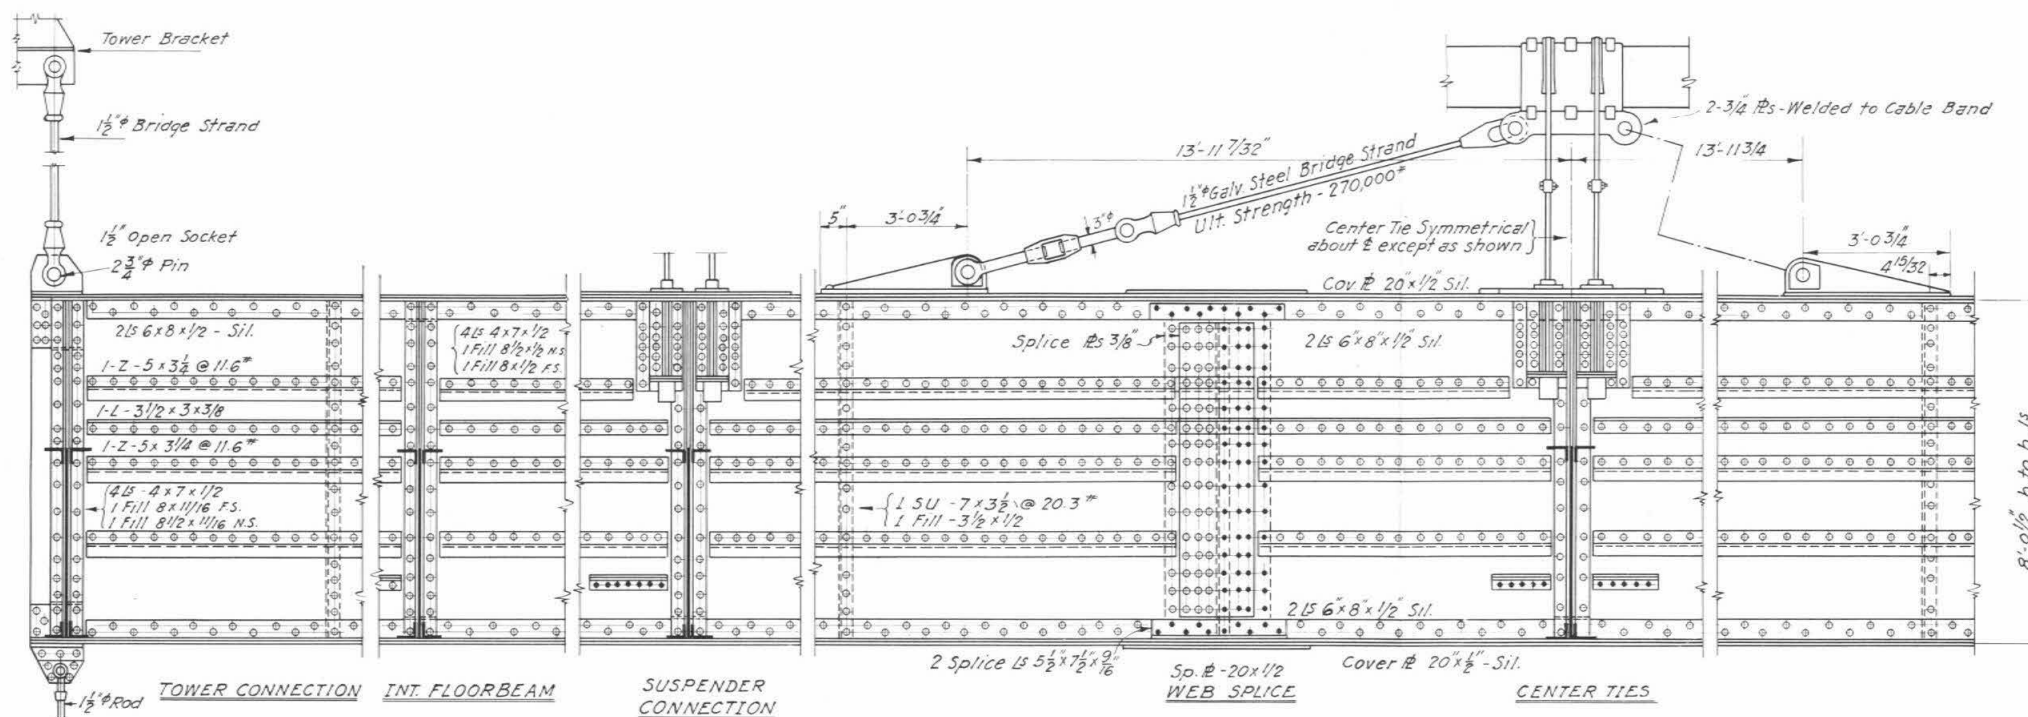
TYPICAL DETAILS OF STIFFENING GIRDERS

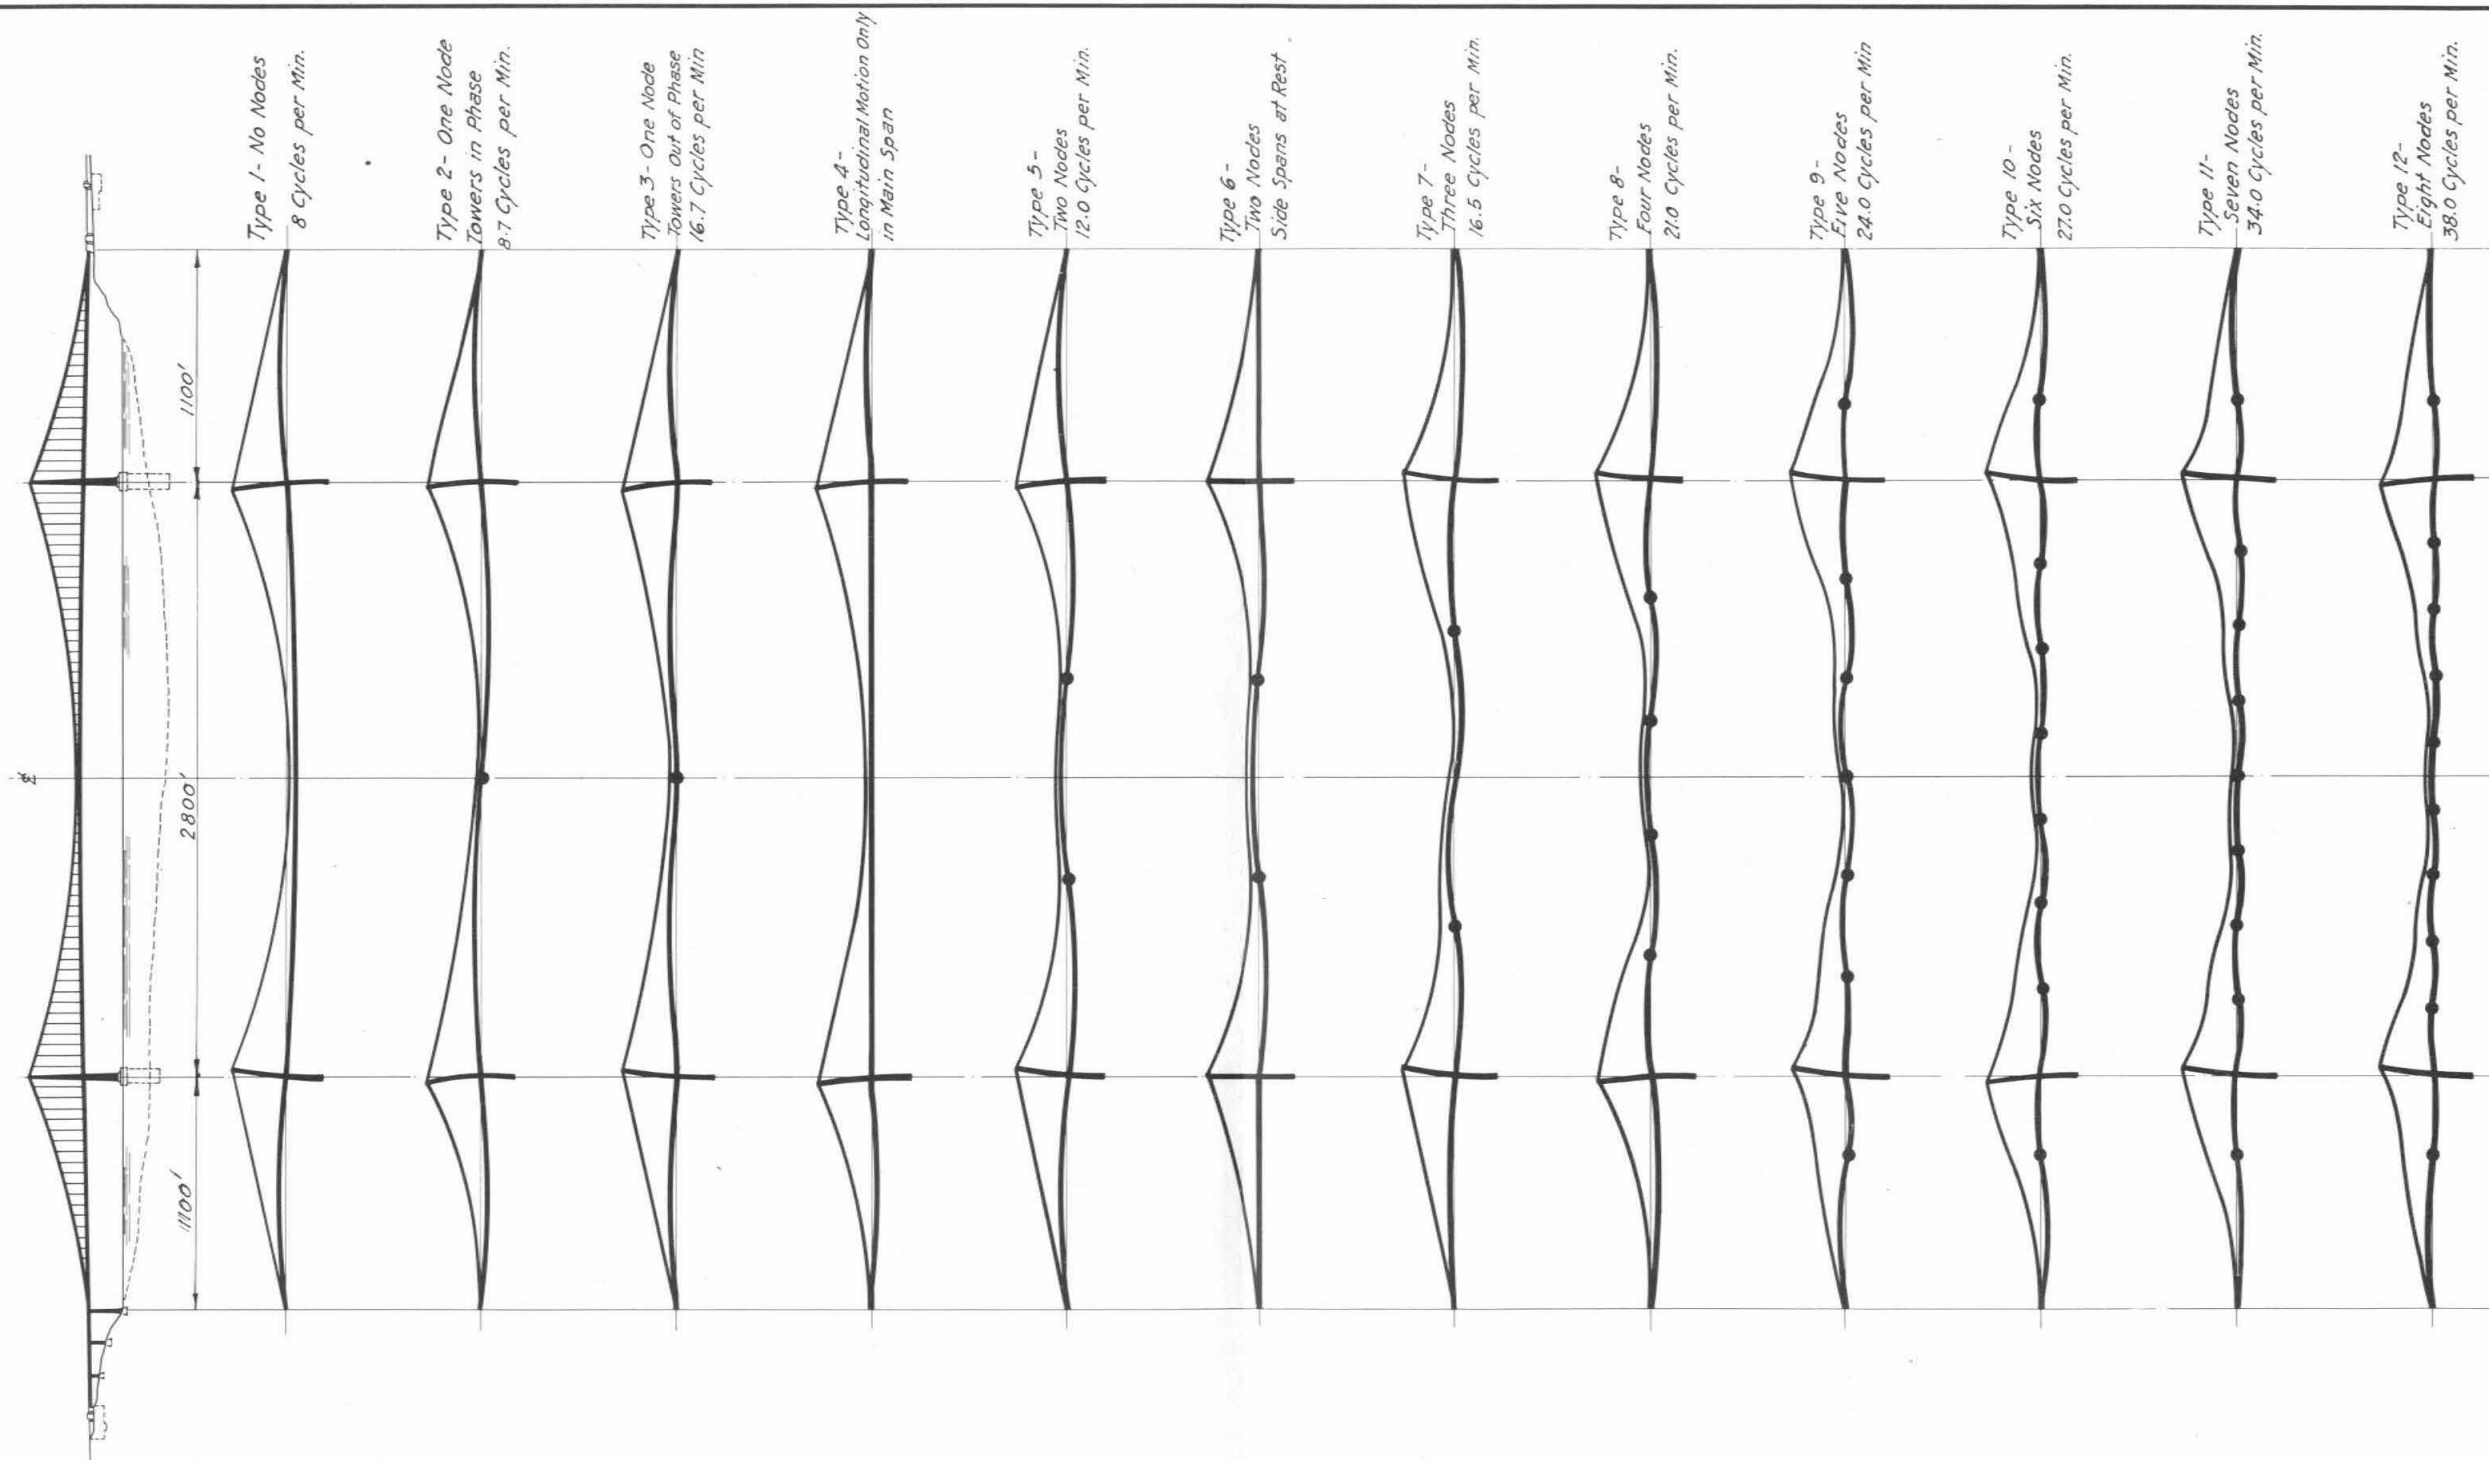
DRAWING 4

NOTE:  
The various Types, 1-12, of oscillations shown on this drawing are reproduced from information furnished by Professor F. B. Farquharson of the University of Washington.

Refer to Tables 1 & 2 and  
Drawing 4 for Type Numbers

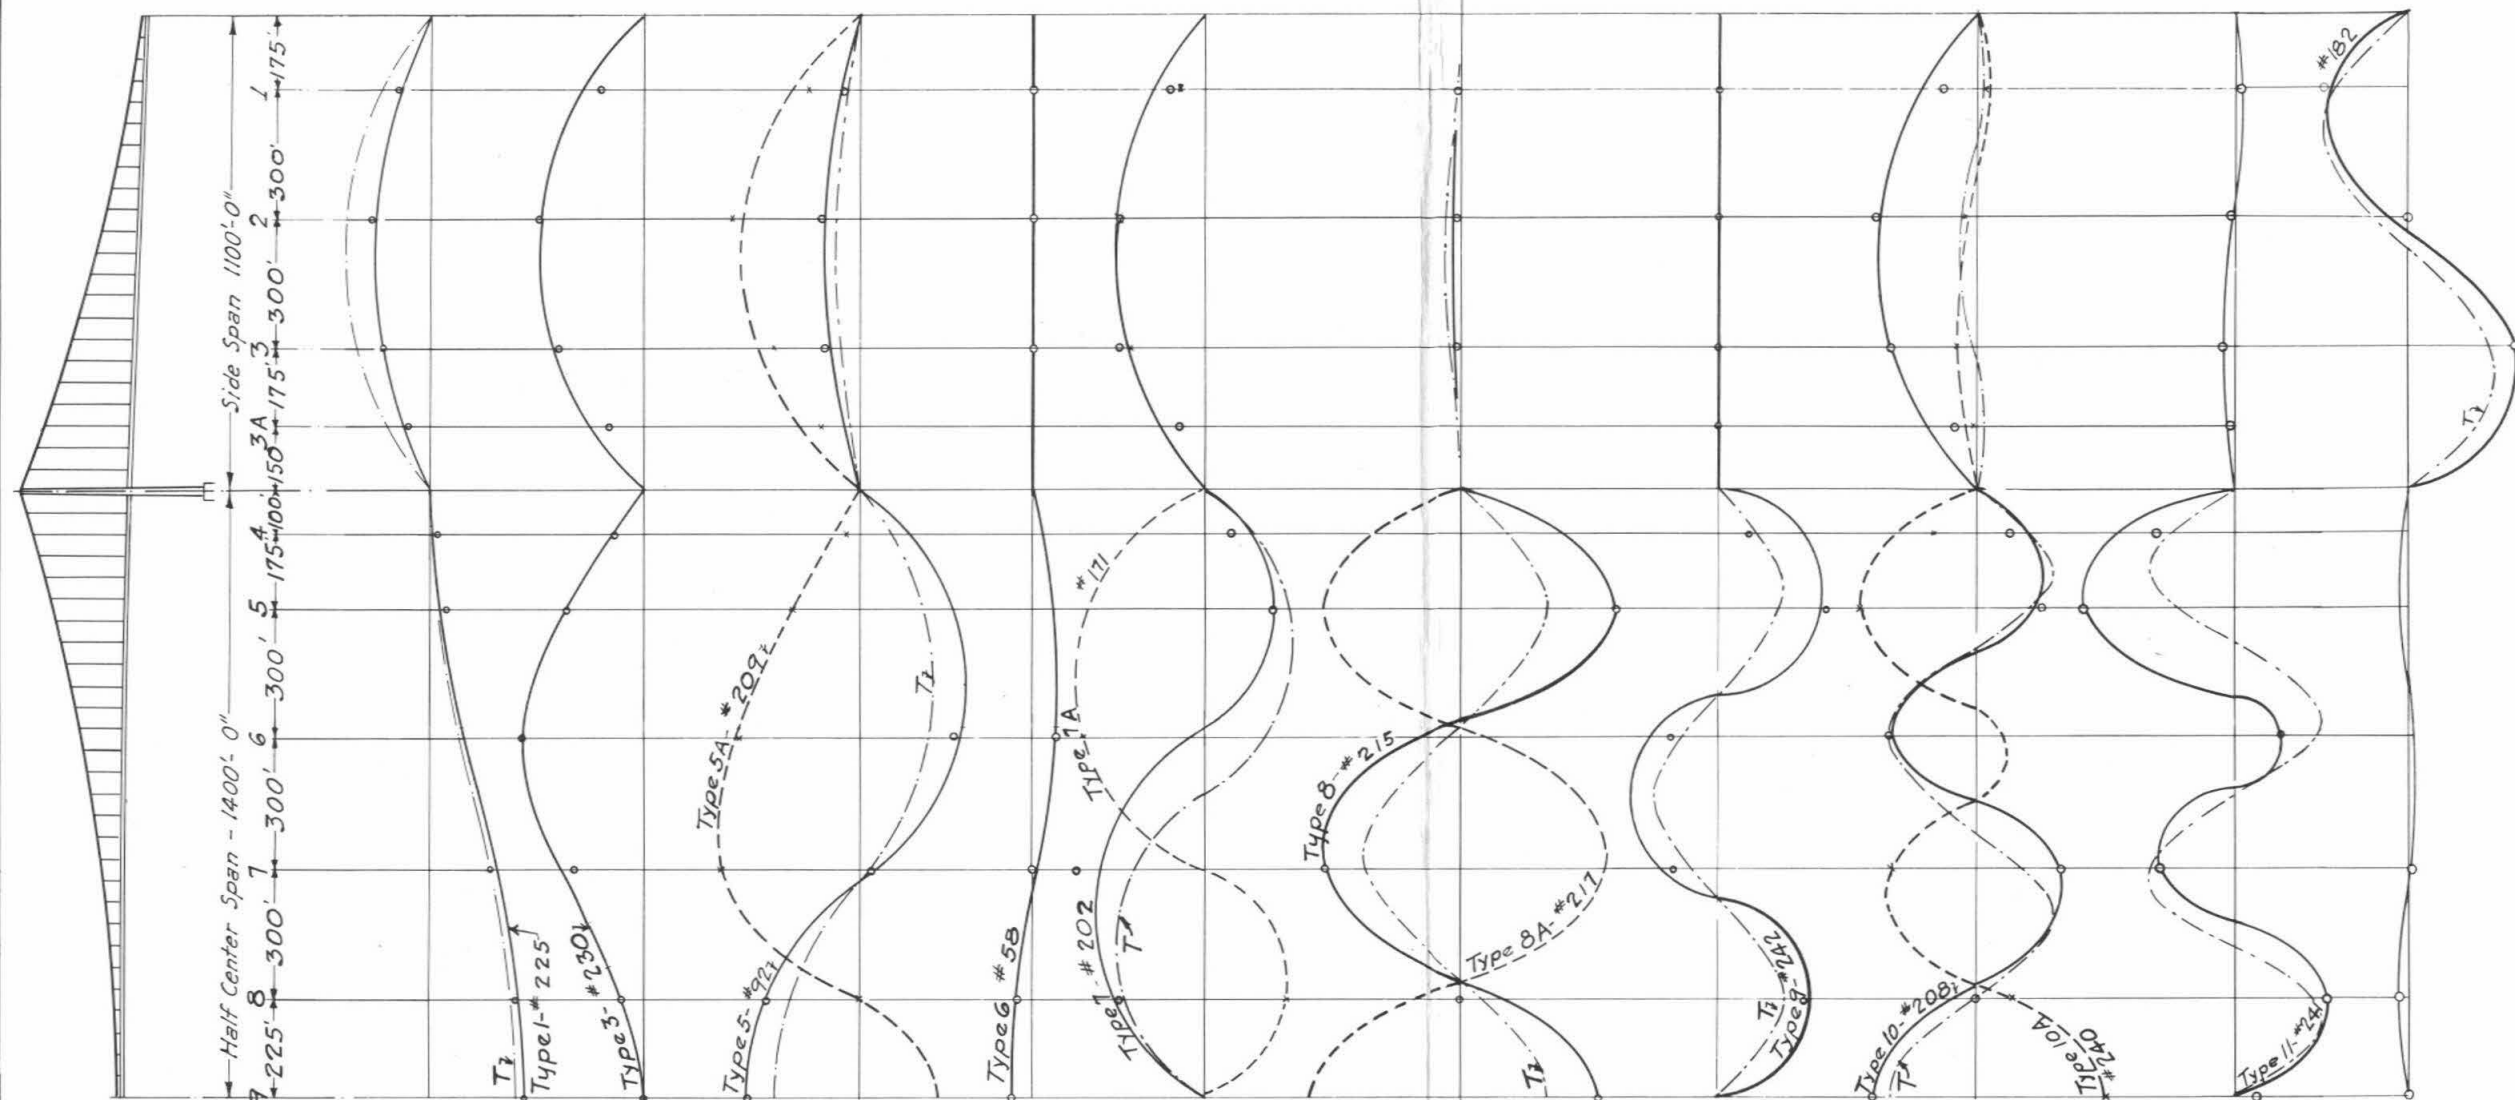
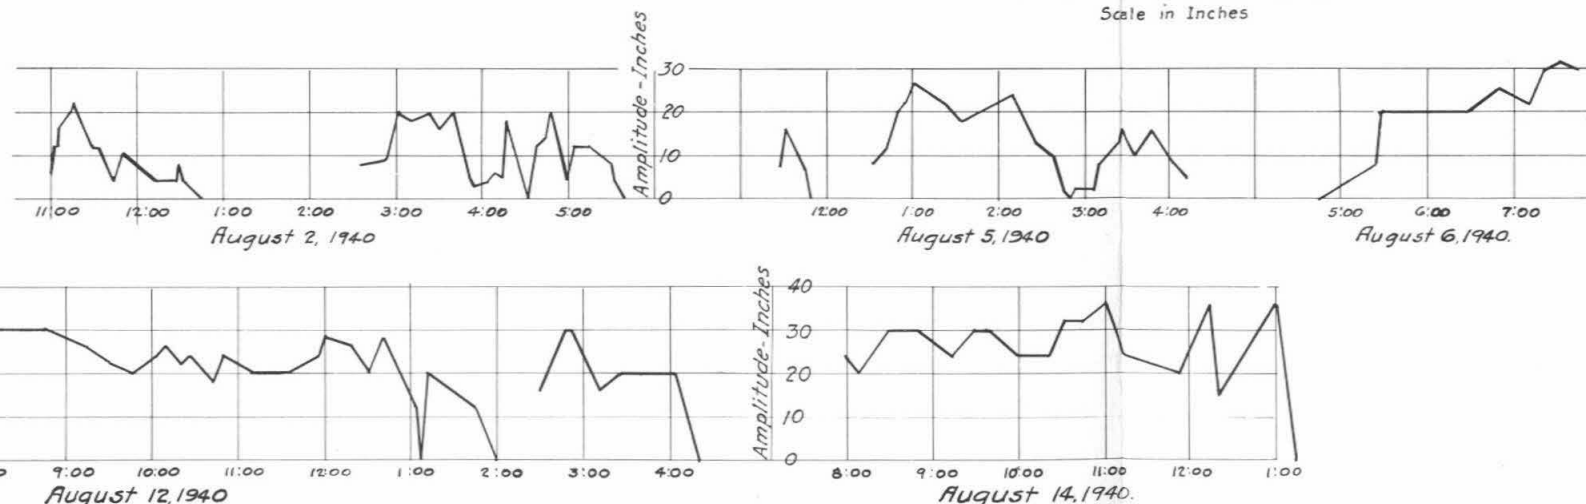
Target No.  
Target Spacing

Note:  
Numbers are Observation Numbers from Tables 1 and 2  
Types refer to Mode of Oscillation Drawing #4  
"T" indicates Theoretical Oscillations with assumed maximum amplitude of 20" for the various types.  
o-Indicates observations for oscillations shown by full lines.  
x-Indicates observations for oscillations shown by dashed lines.
